CGW Ref: 240316-MEMO-003-A

240316 – Koreke Rise Stormwater – Infiltration Testing Results Summary

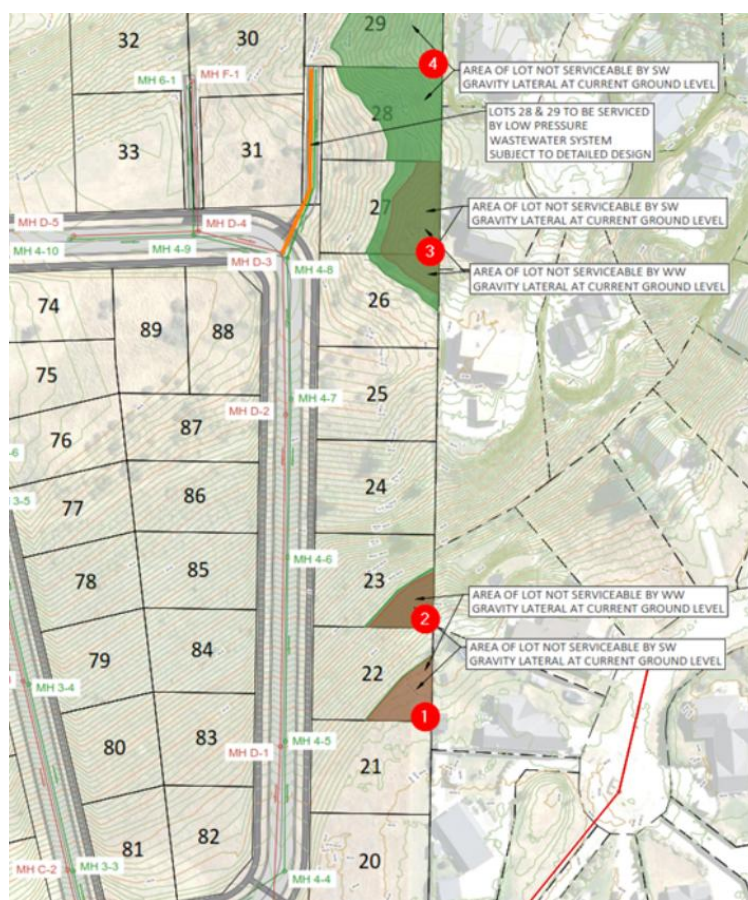
Figure 1: Approximate infiltration testing locations throughout Koreke Rise

Test pits 2, 3 and 4 appeared to be located on the glacial terminal moraine, whereas test pit 1 appears to be close to the intersection between the toe of the glacial moraine and outwash deposits to the south of the site.
