**WILLOWRIDGE
DEVELOPMENTS LIMITED**

195 LAKE VIEW TERRACE,
HAWEA

**GEOTECHNICAL ASSESSMENT FOR PROPOSED
RESIDENTIAL SUBDIVISION: LAKE VIEW TERRACE**

REF: R5160-1A
DATE: 23 OCTOBER 2019

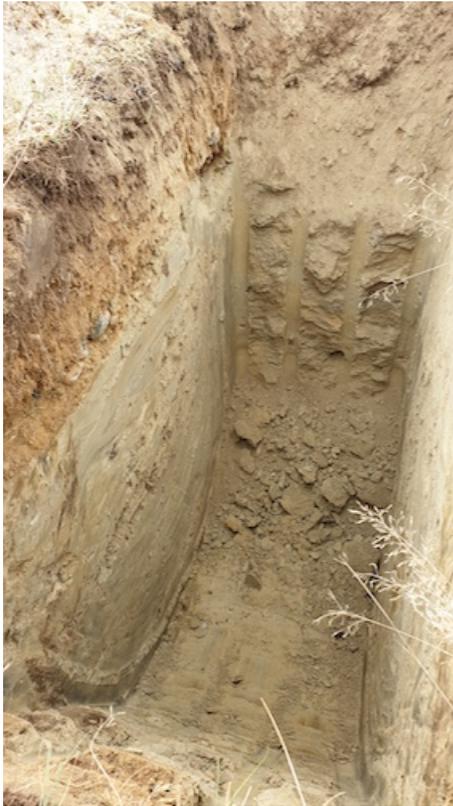
TP101

PIT EXCAVATION

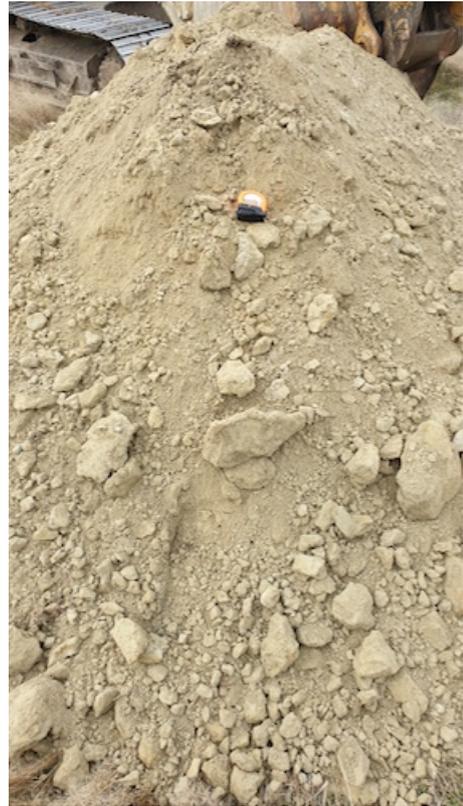
ARISINGS

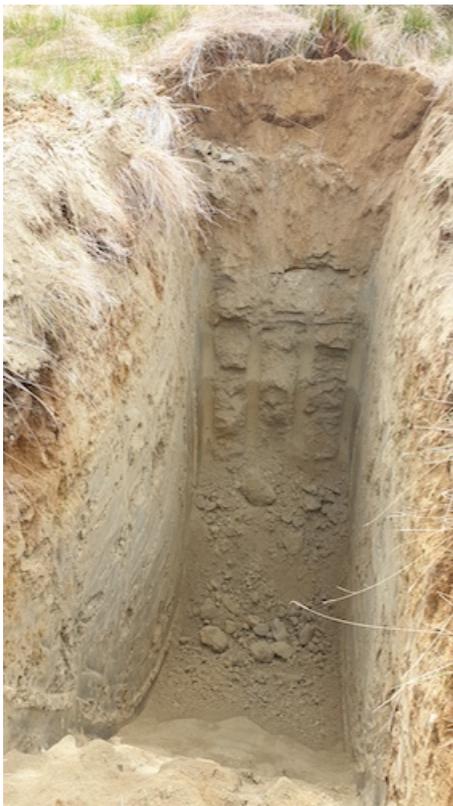
TP102

PIT EXCAVATION

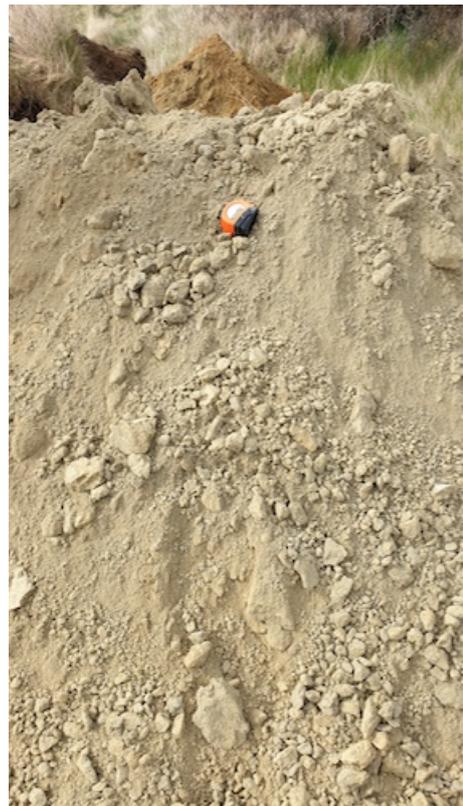
ARISINGS

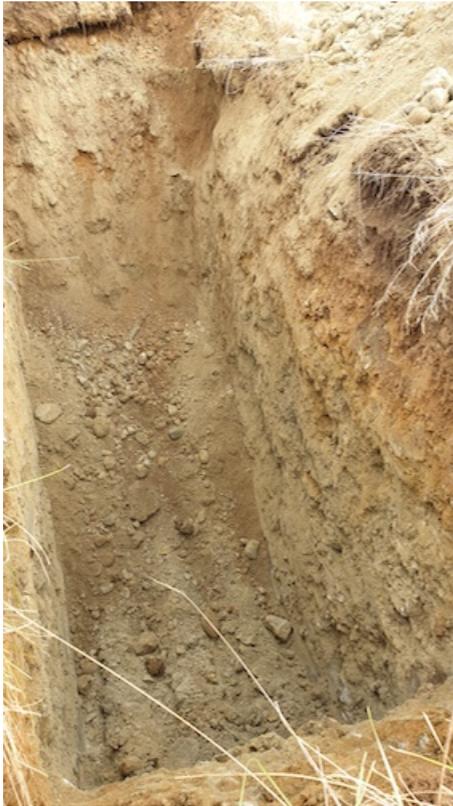
TP103

PIT EXCAVATION

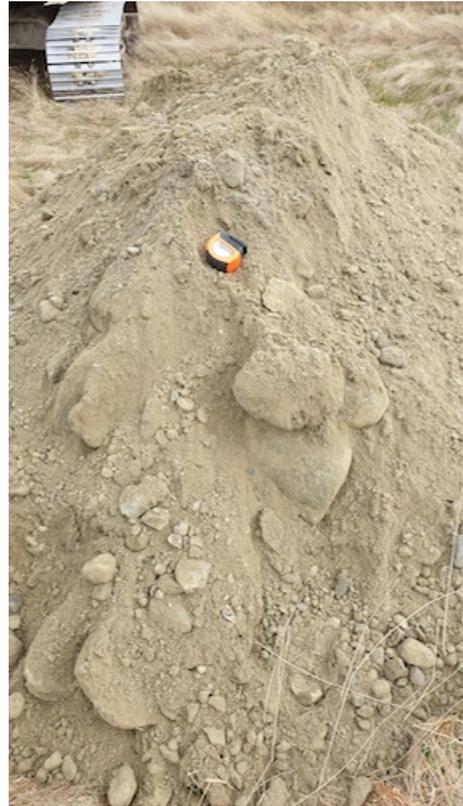
ARISINGS

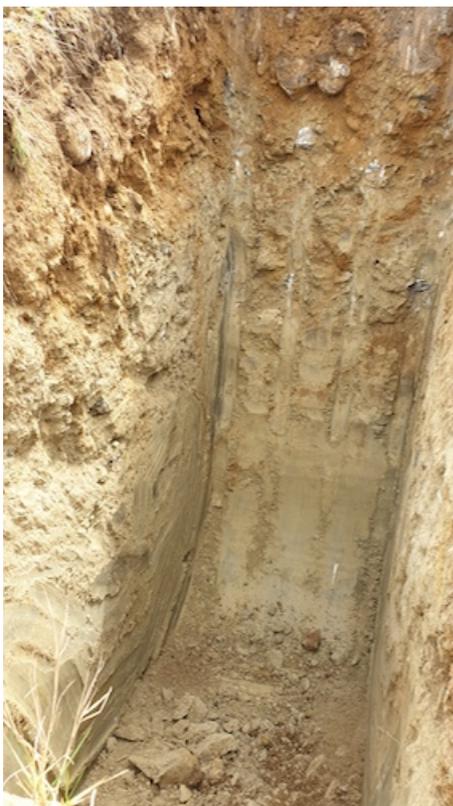
TP104

PIT EXCAVATION

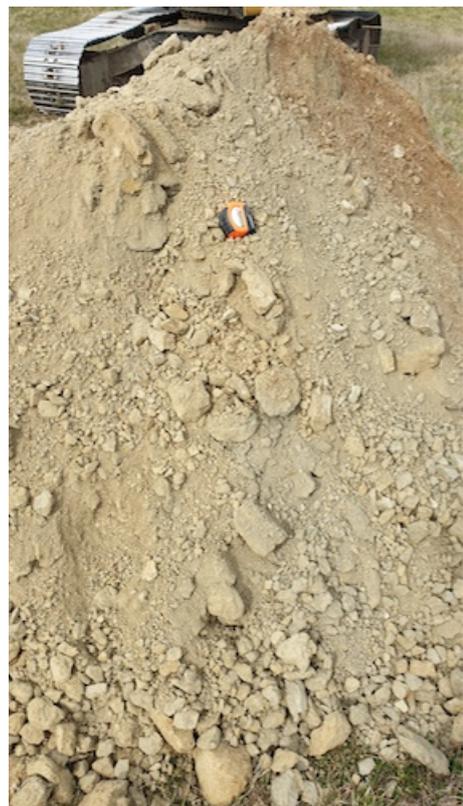
ARISINGS

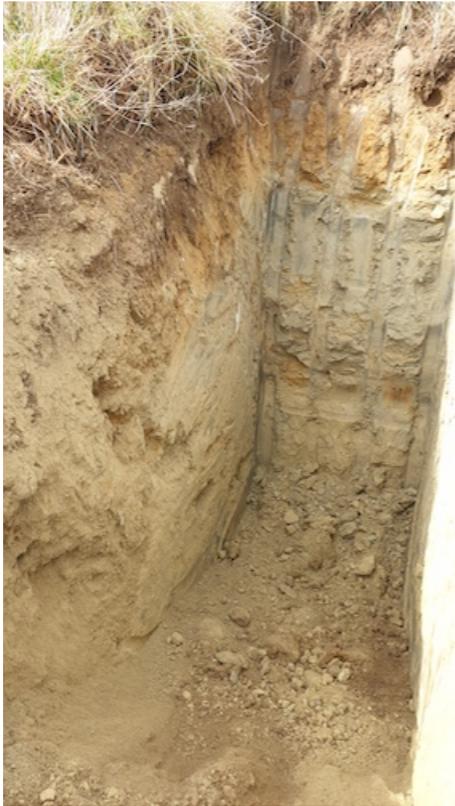
TP105

PIT EXCAVATION

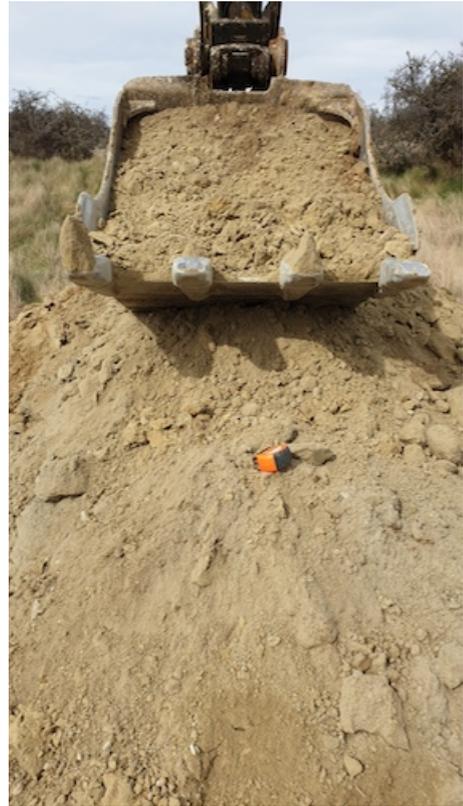
ARISINGS

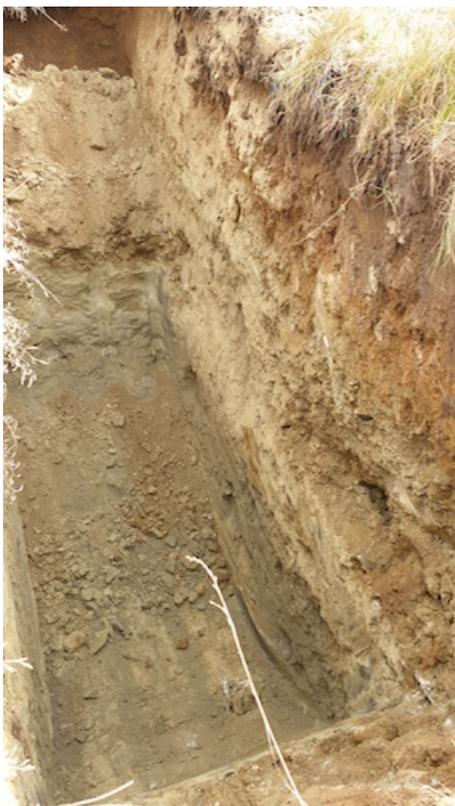
TP106

PIT EXCAVATION

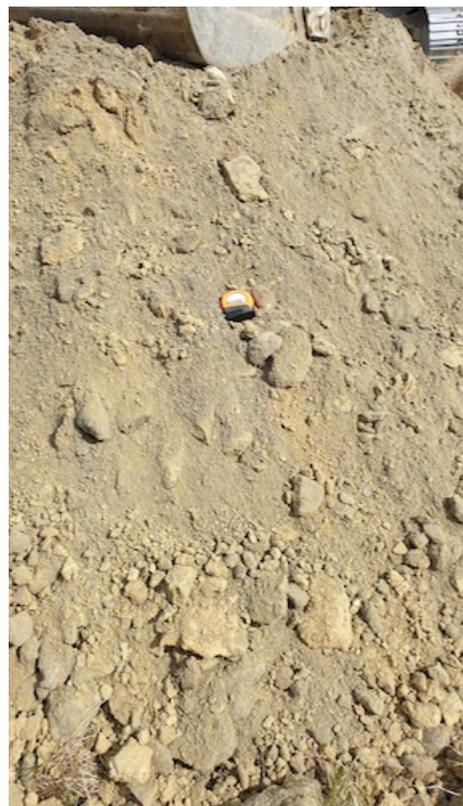
ARISINGS

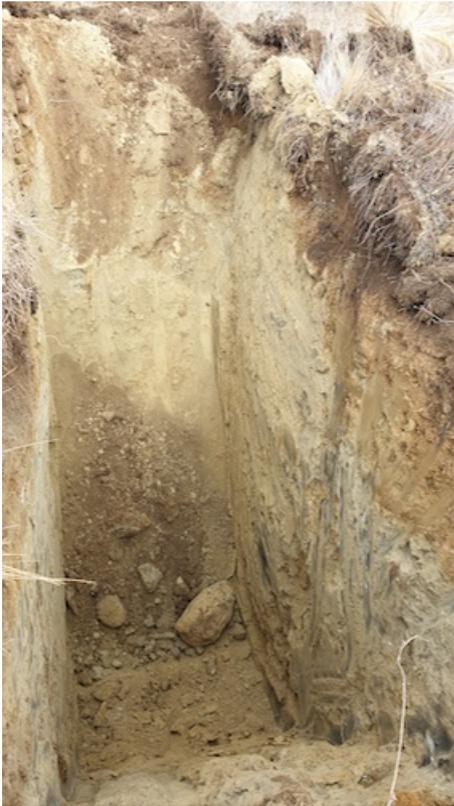
TP107

PIT EXCAVATION

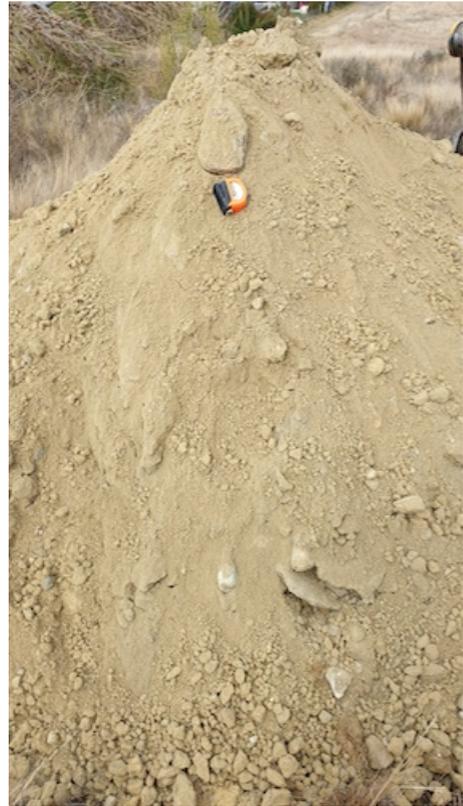
ARISINGS

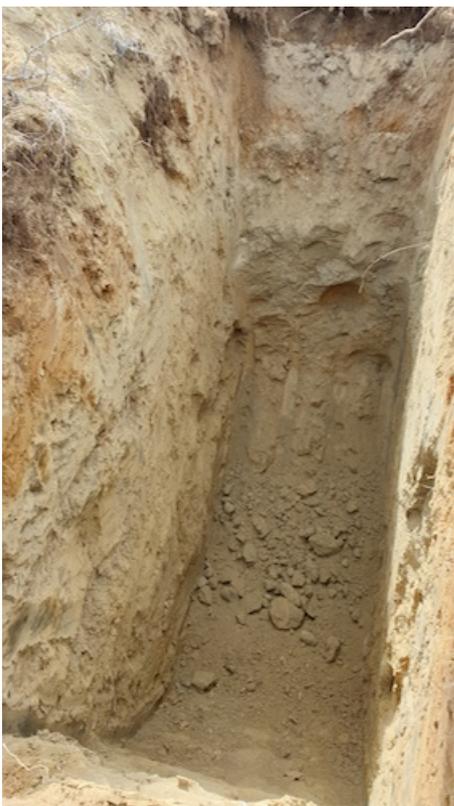
TP108

PIT EXCAVATION

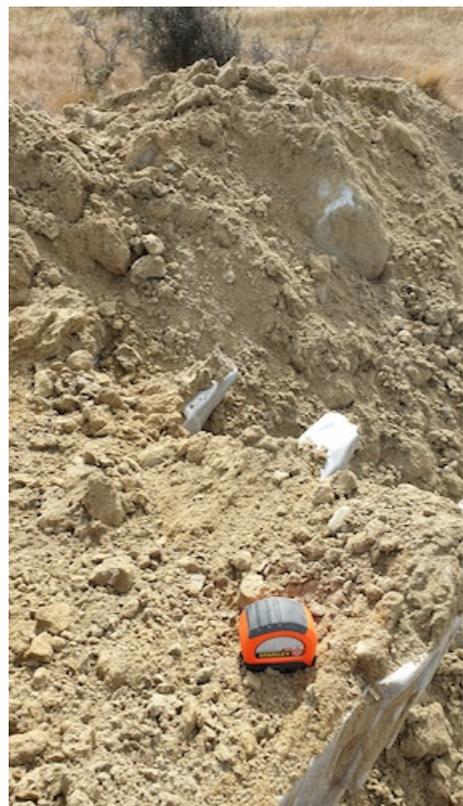
ARISINGS

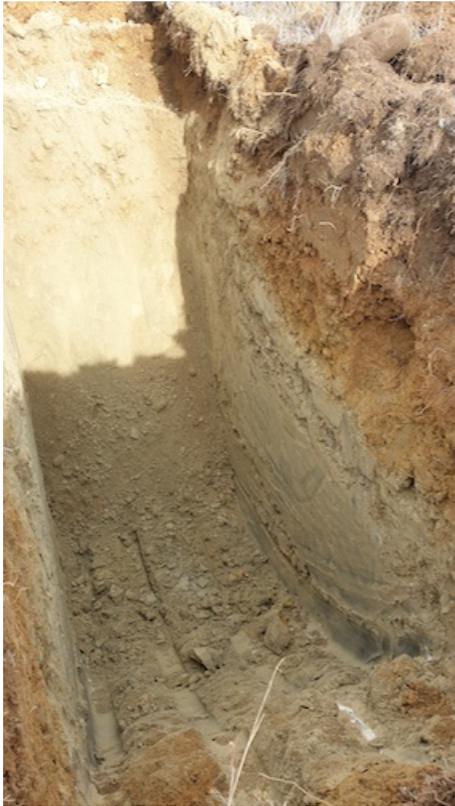
TP109

PIT EXCAVATION

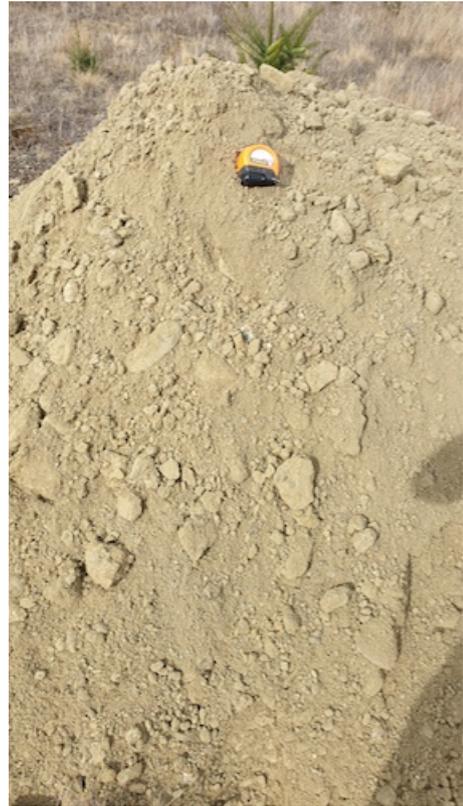
ARISINGS

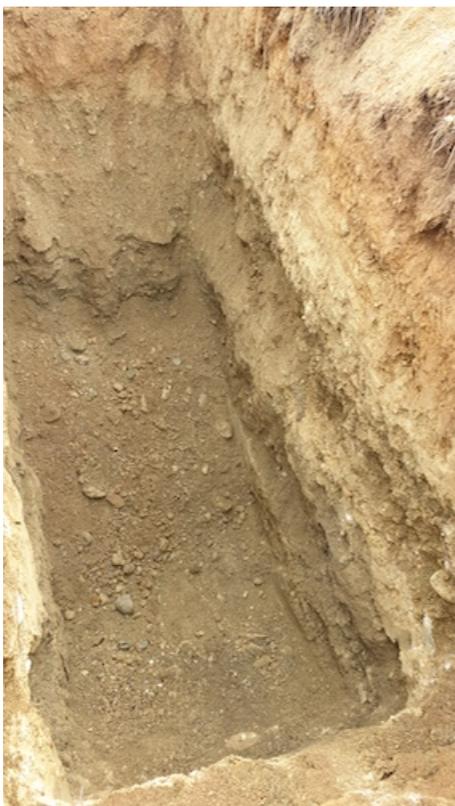
TP110

PIT EXCAVATION

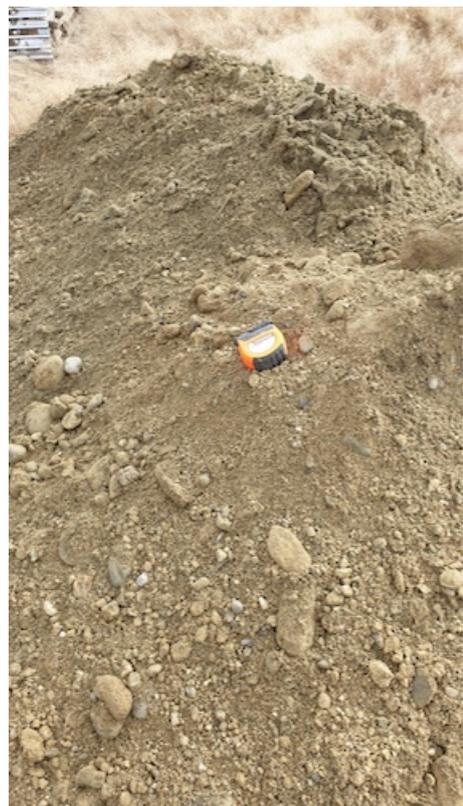
ARISINGS

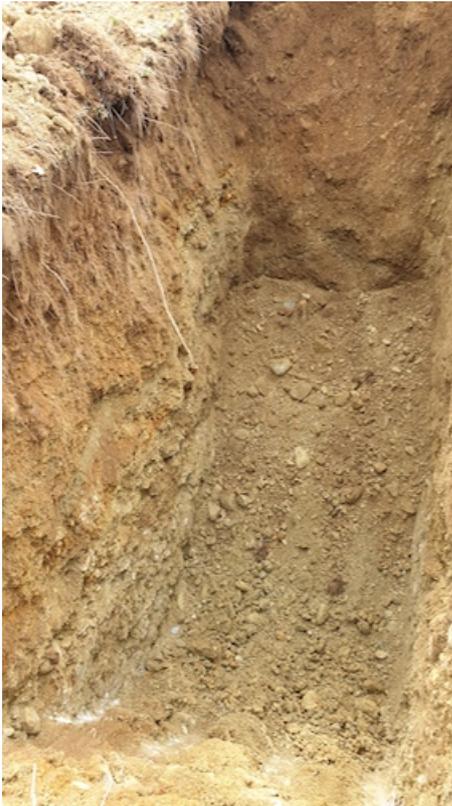
TP111

PIT EXCAVATION

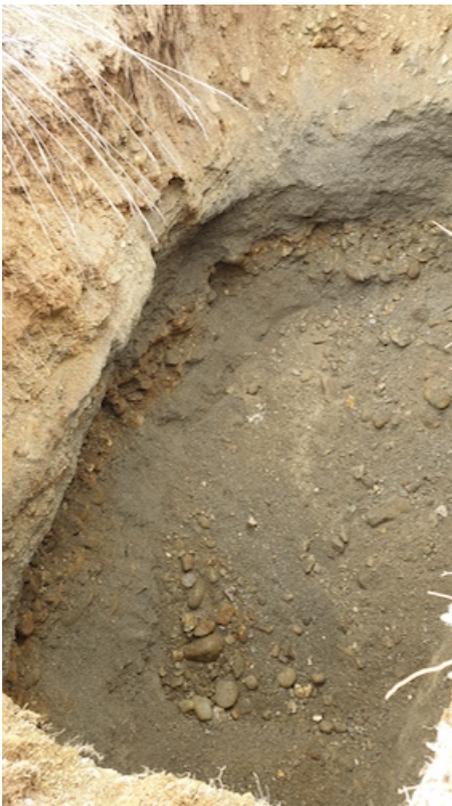
TP112

PIT EXCAVATION

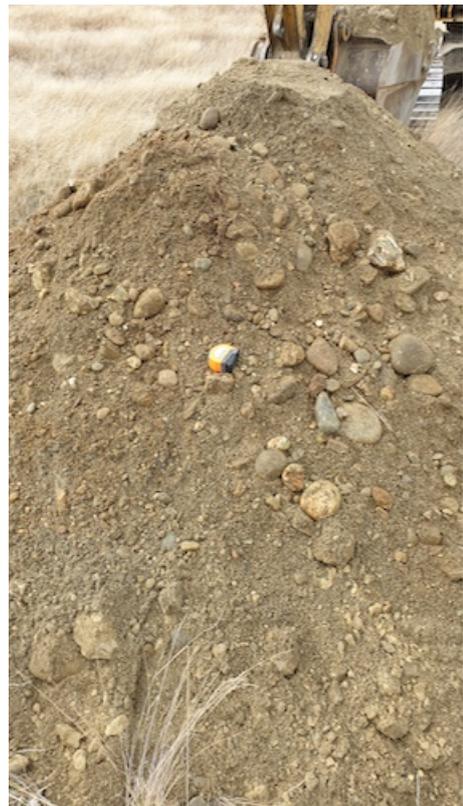
ARISINGS

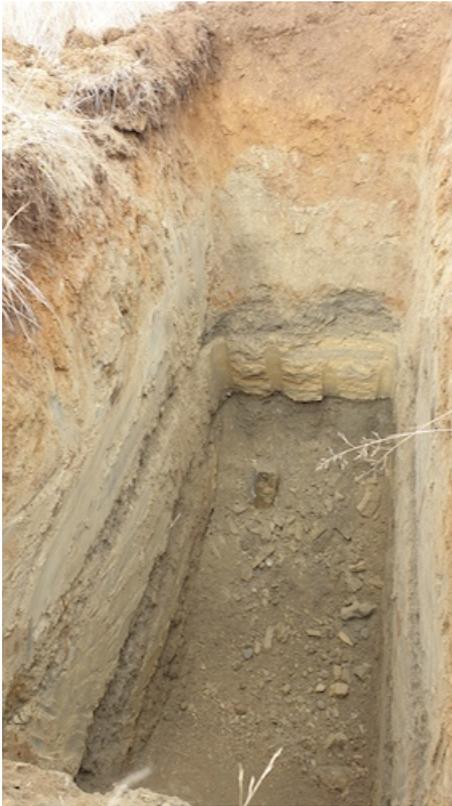
TP113

PIT EXCAVATION

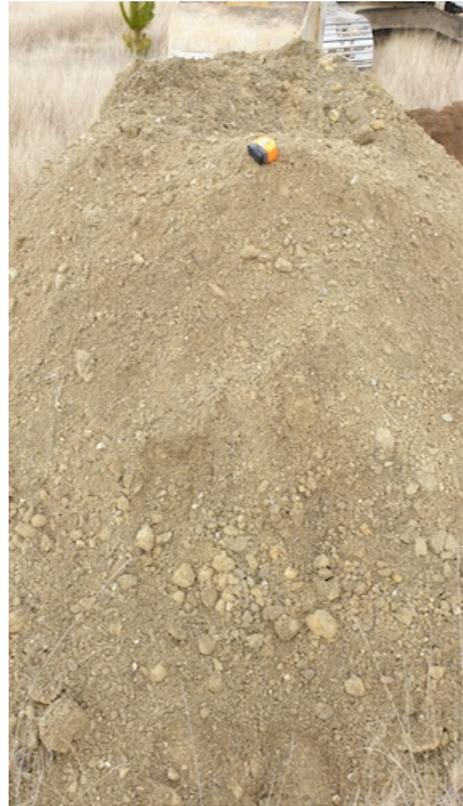
ARISINGS

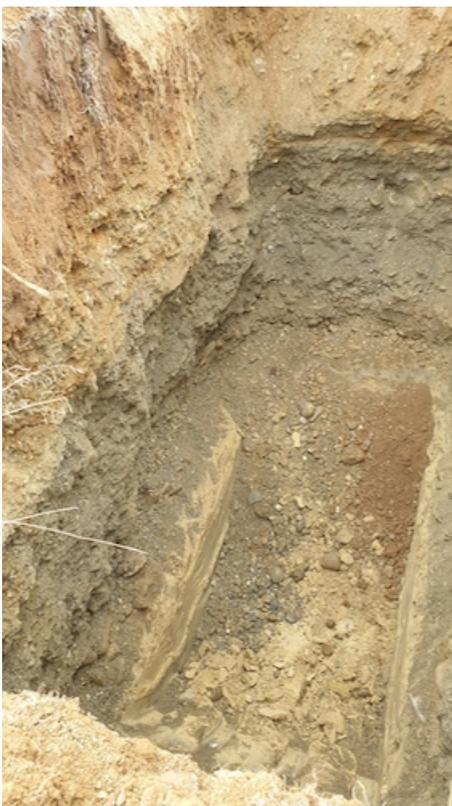
TP114

PIT EXCAVATION

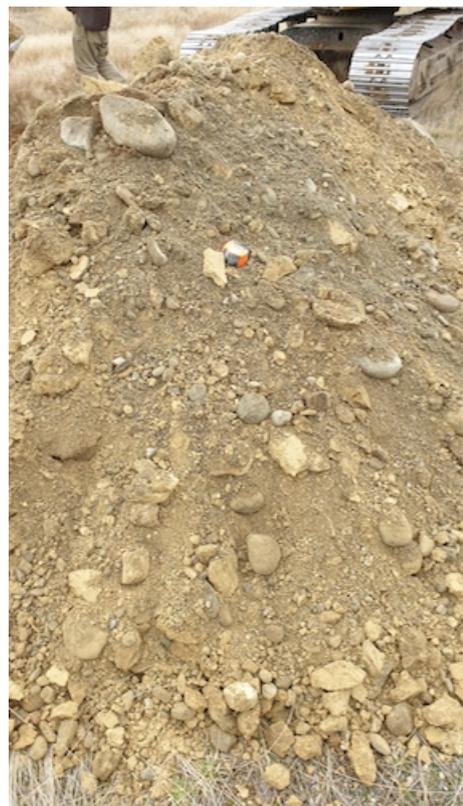
ARISINGS

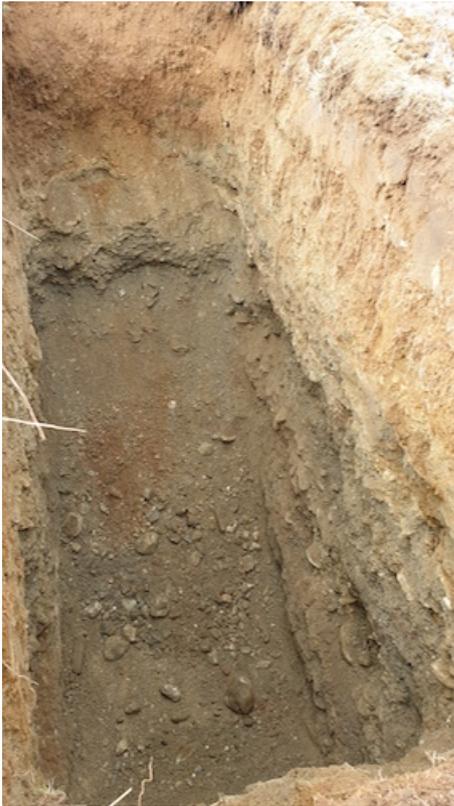
TP115

PIT EXCAVATION

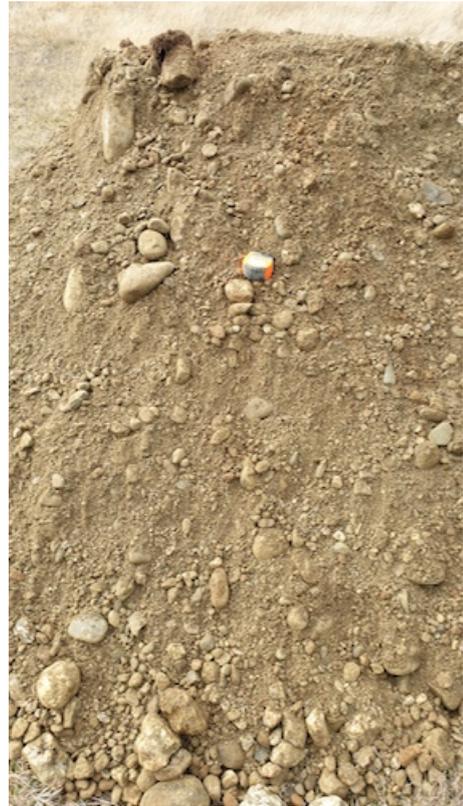
ARISINGS

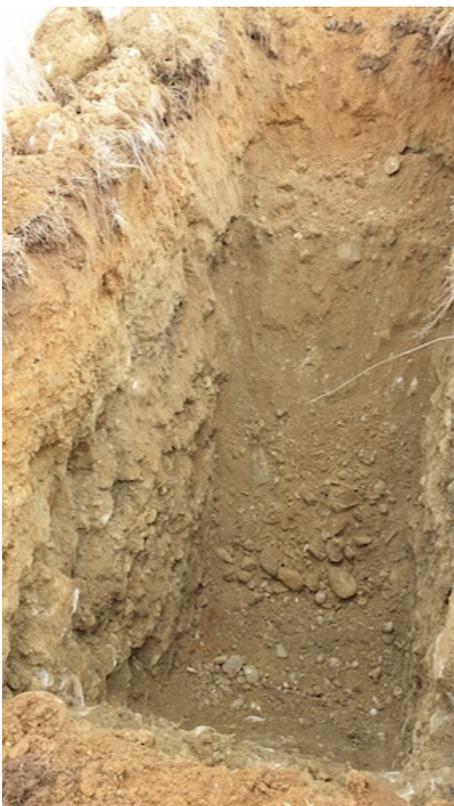
TP116

PIT EXCAVATION

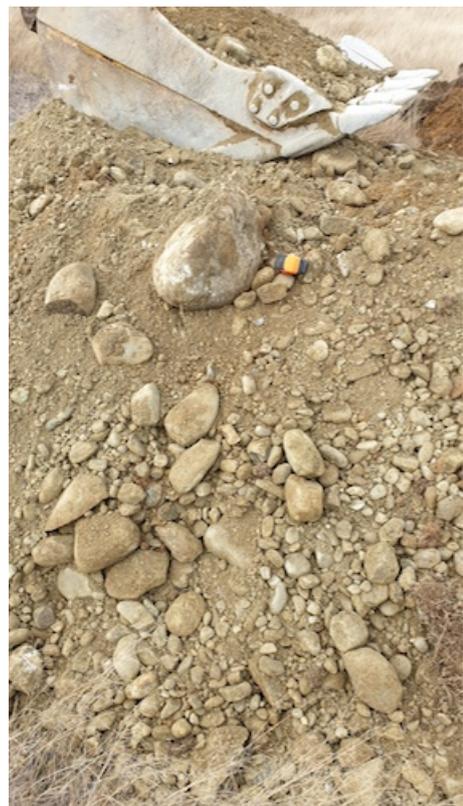
ARISINGS

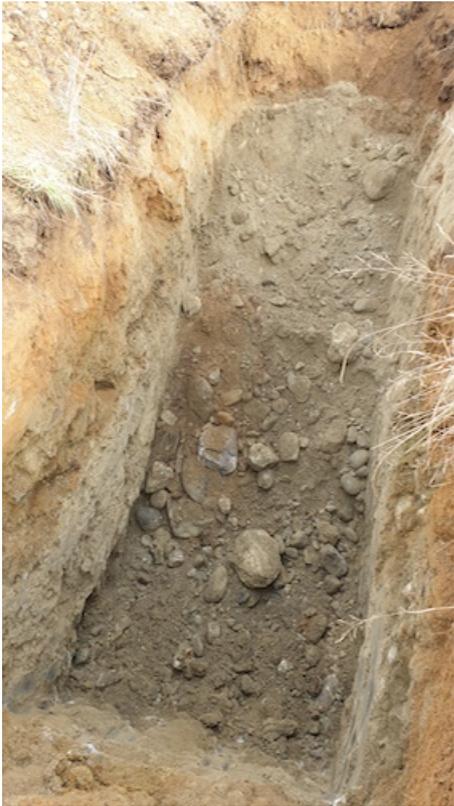
TP117

PIT EXCAVATION

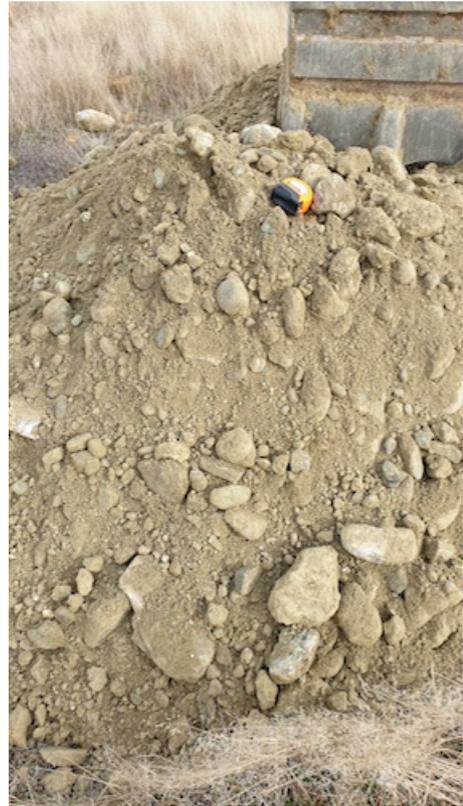
ARISINGS

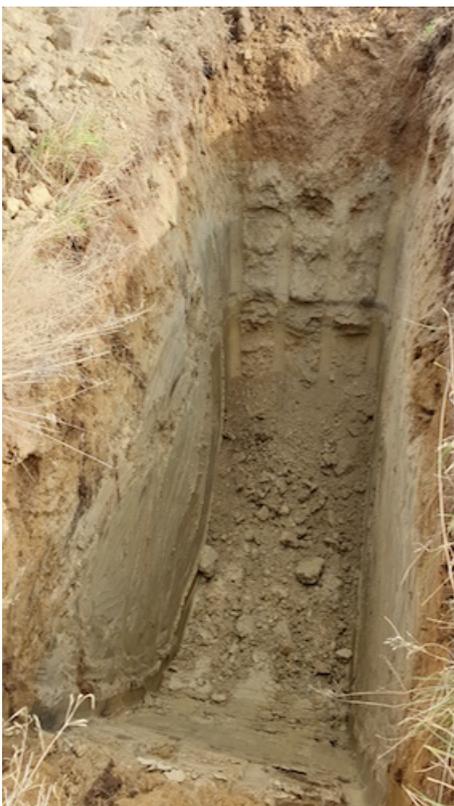
TP118

PIT EXCAVATION

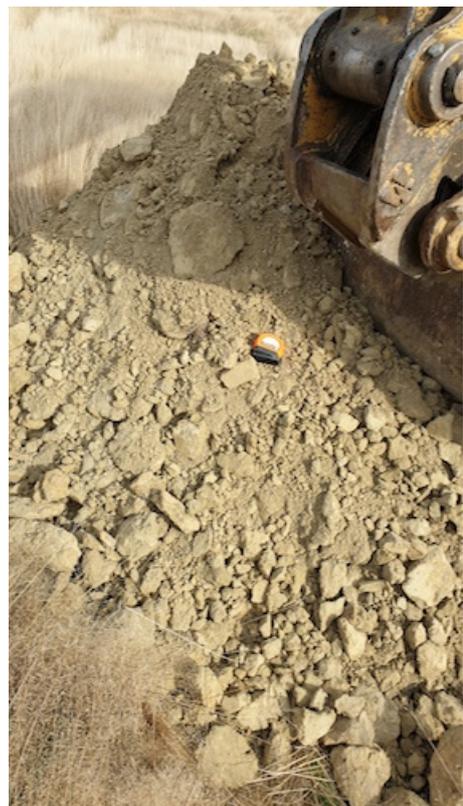
ARISINGS

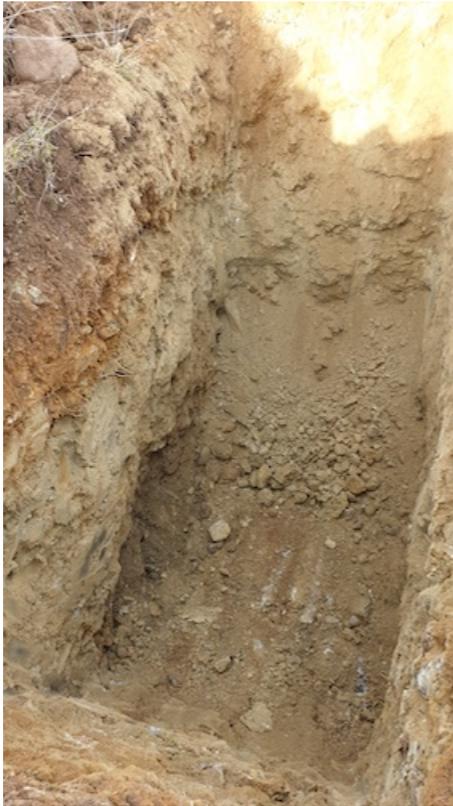
TP119

PIT EXCAVATION

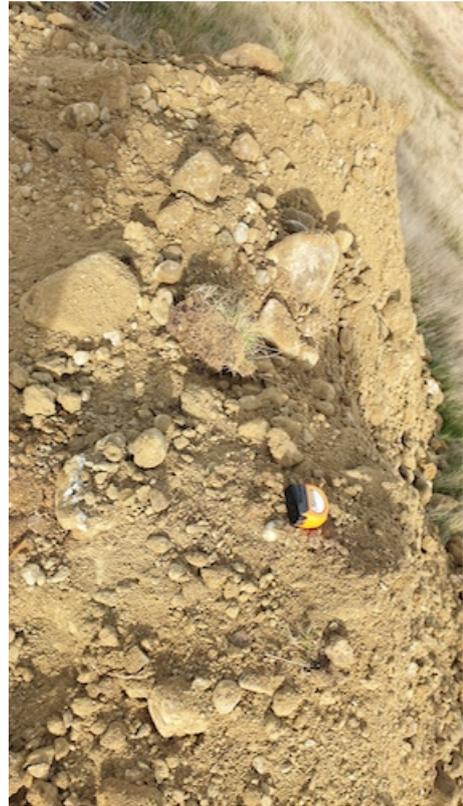
ARISINGS

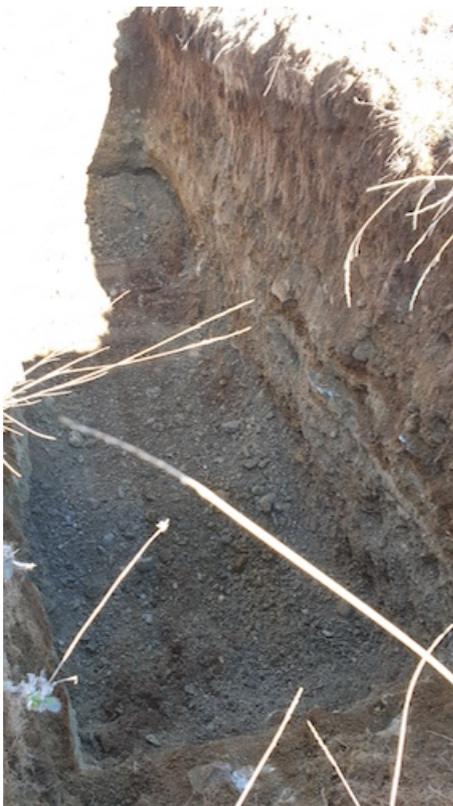
TP120

PIT EXCAVATION

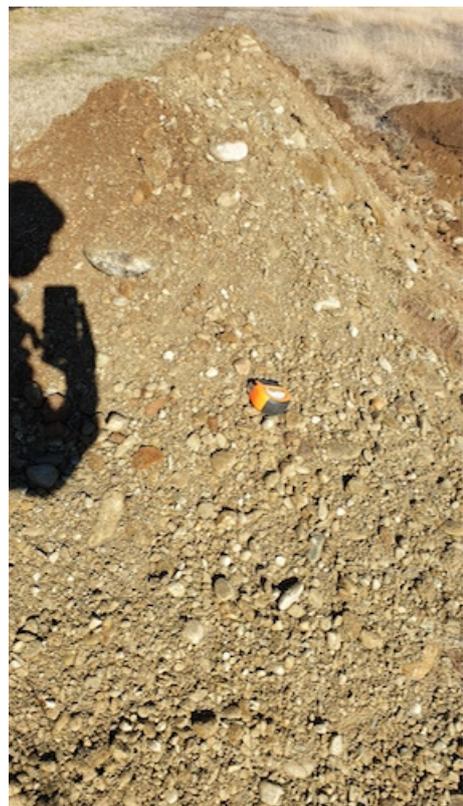
ARISINGS

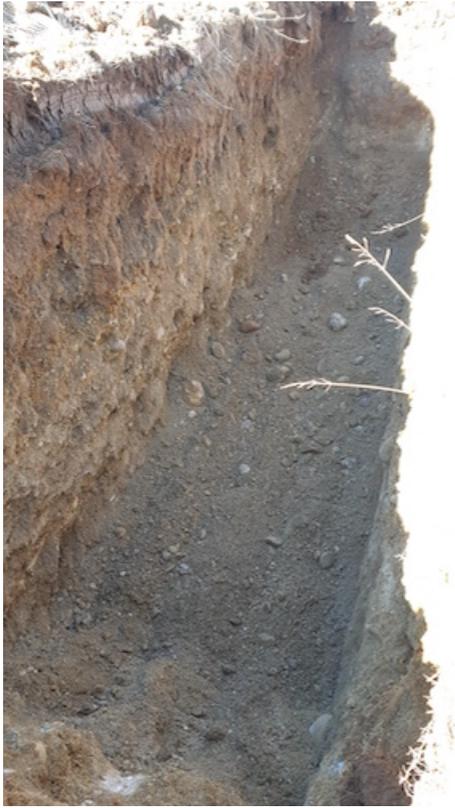
TP121

PIT EXCAVATION

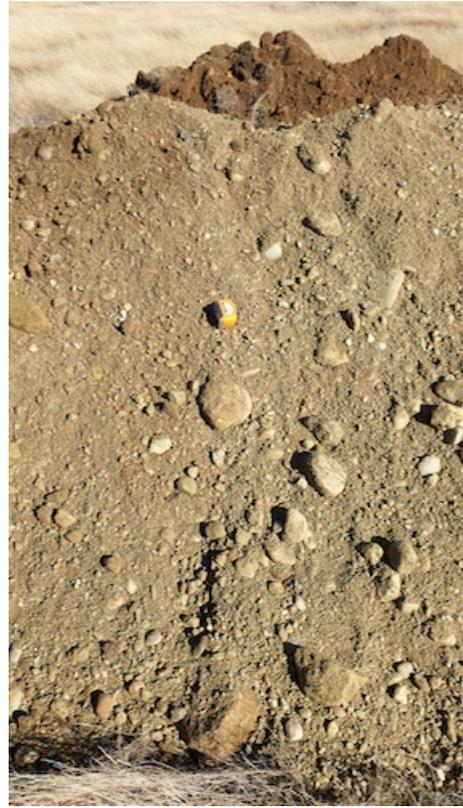
ARISINGS

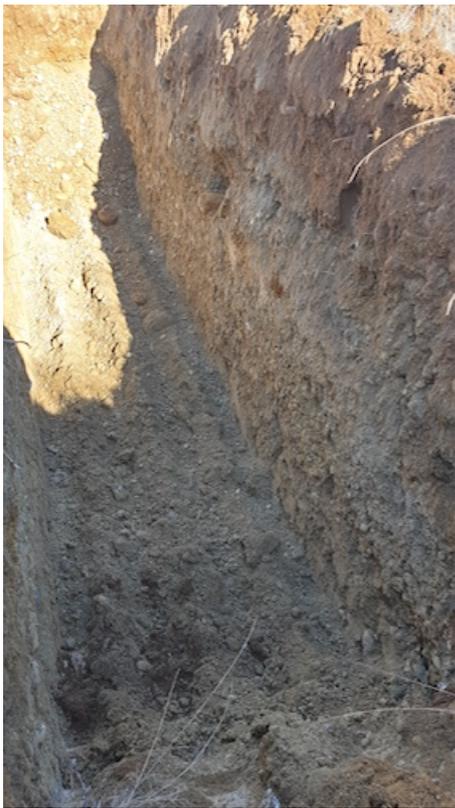
TP122

PIT EXCAVATION

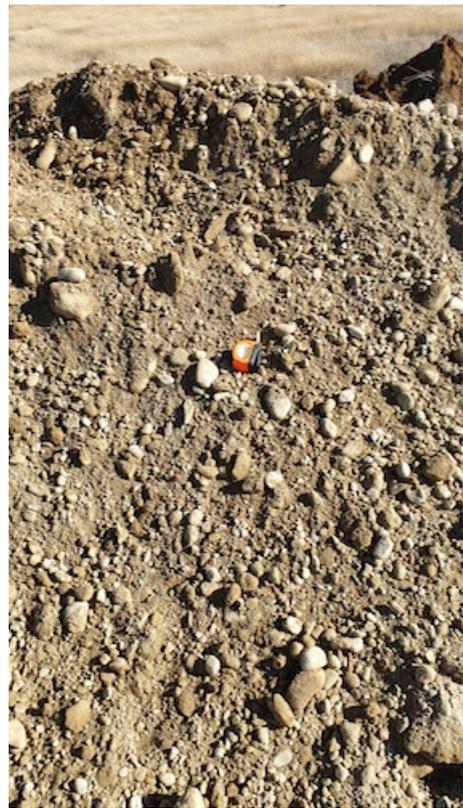
ARISINGS

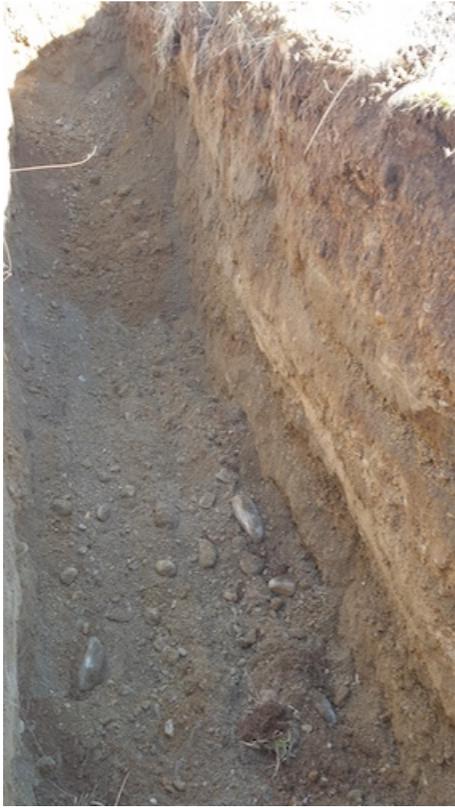
PIT EXCAVATION

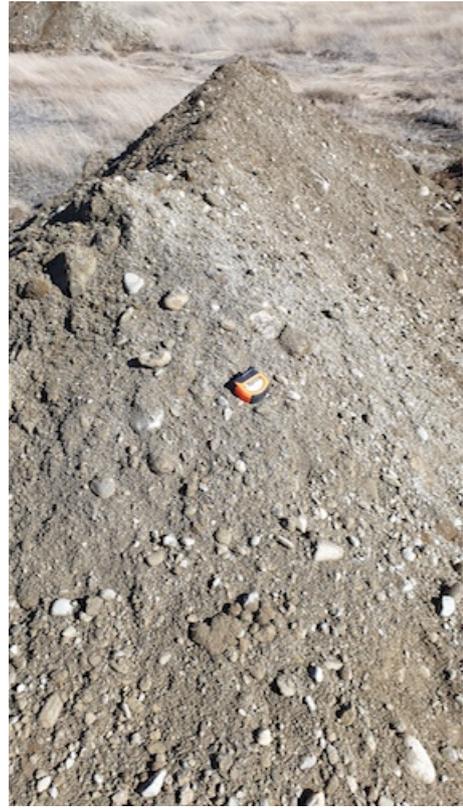
ARISINGS
